# ROAD UTILITY CUTS

## Field Investigation

*Toronto Site*

Report No.: B-5506.25

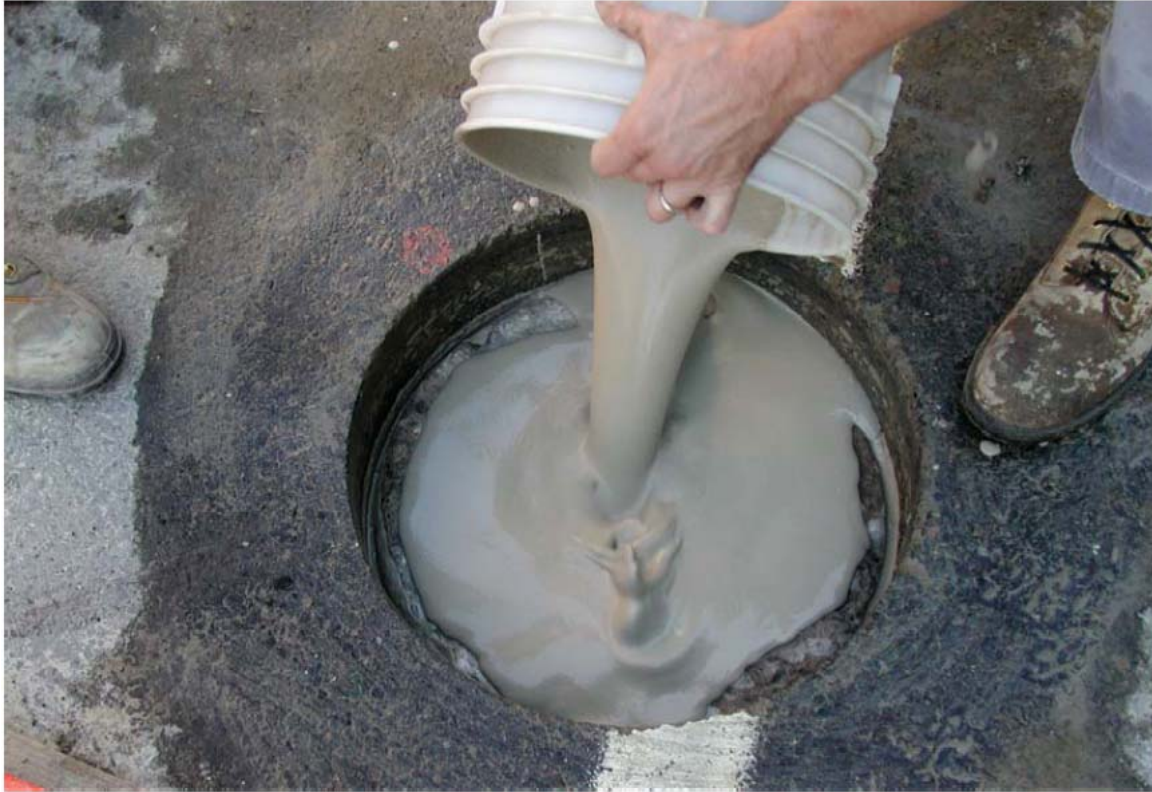
Figure 5.15. Grout poured into keyhole on top of PCC delaminated segment

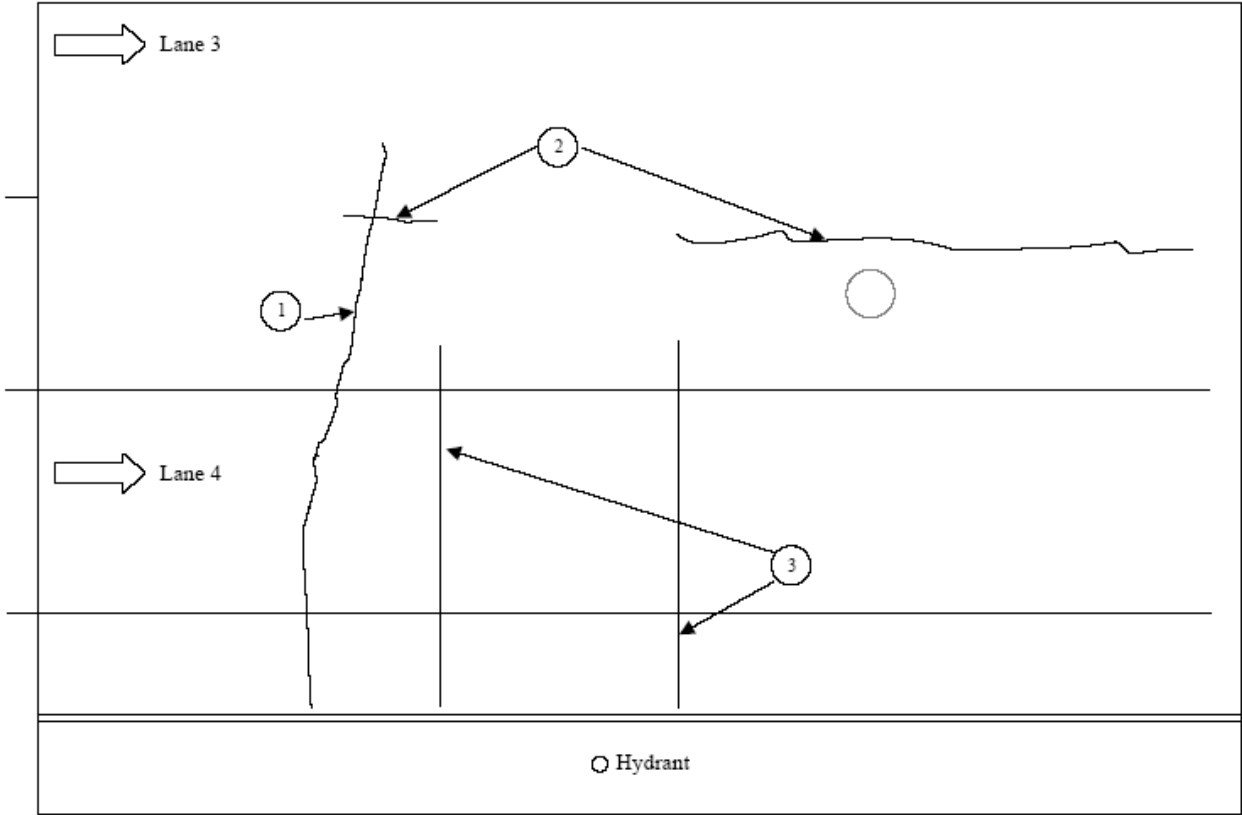
Figure 9.1. Damage survey map

Observations made during these site visits are summarized in Table 9.1 and shown in Figure 9.1. Images that captured different distress types are also identified in Table 9.1. Damage types observed at the end of the temporary restoration stage included:

- ❑ The joint between the road and the cut opened
- ❑ Excessive settlement along the wheel path (further discussion in Section 9.2)

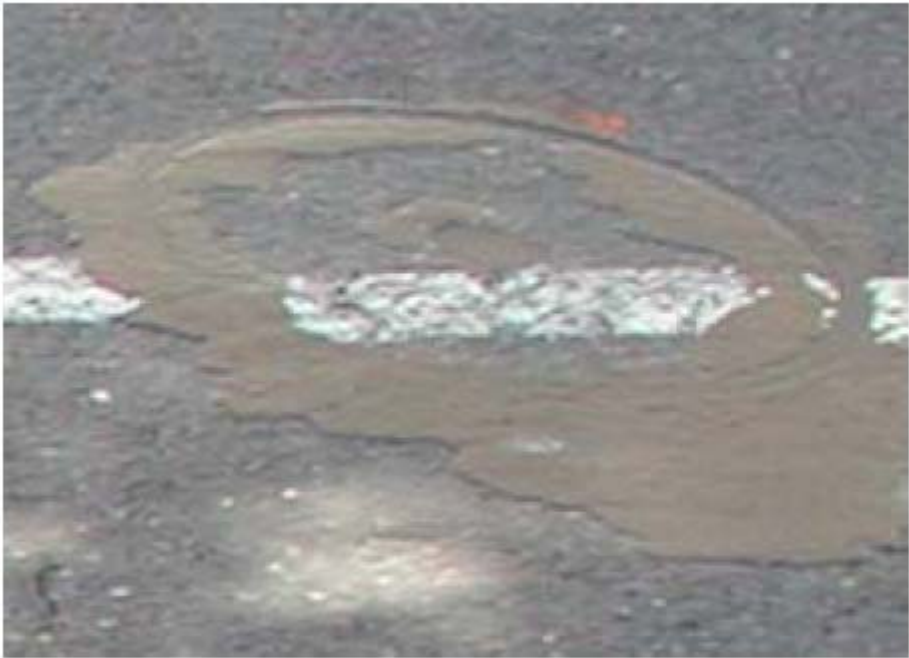
Figure 9.4. Keyhole

The keyhole section established on October 2001 continued to perform well throughout the life of the experiment. The surface of the restored keyhole remained at level with the road profile. The grout surrounding the AC/PCC plug remained intact (no cracking or separation).

Note	During construction related to permanent restoration, the steel roller compacting the lower AC layer (HL8) moved in and out of the cut causing damage at the edge of the cut. Placement of a wood beam eliminated the impact of the steel roller movements		See Figures 9.2 and 9.3.
Keyhole	The keyhole restored October 2001 showed no distress during the inspections performed during the May 2002 and April 2003 visits. The grout remained intact and the surface in level with the road.		See Figure 9.4

- ❑ The Toronto experiment showed that the keyhole cutting and restoration technique is effective in limiting damage to the road and its application should be encouraged.

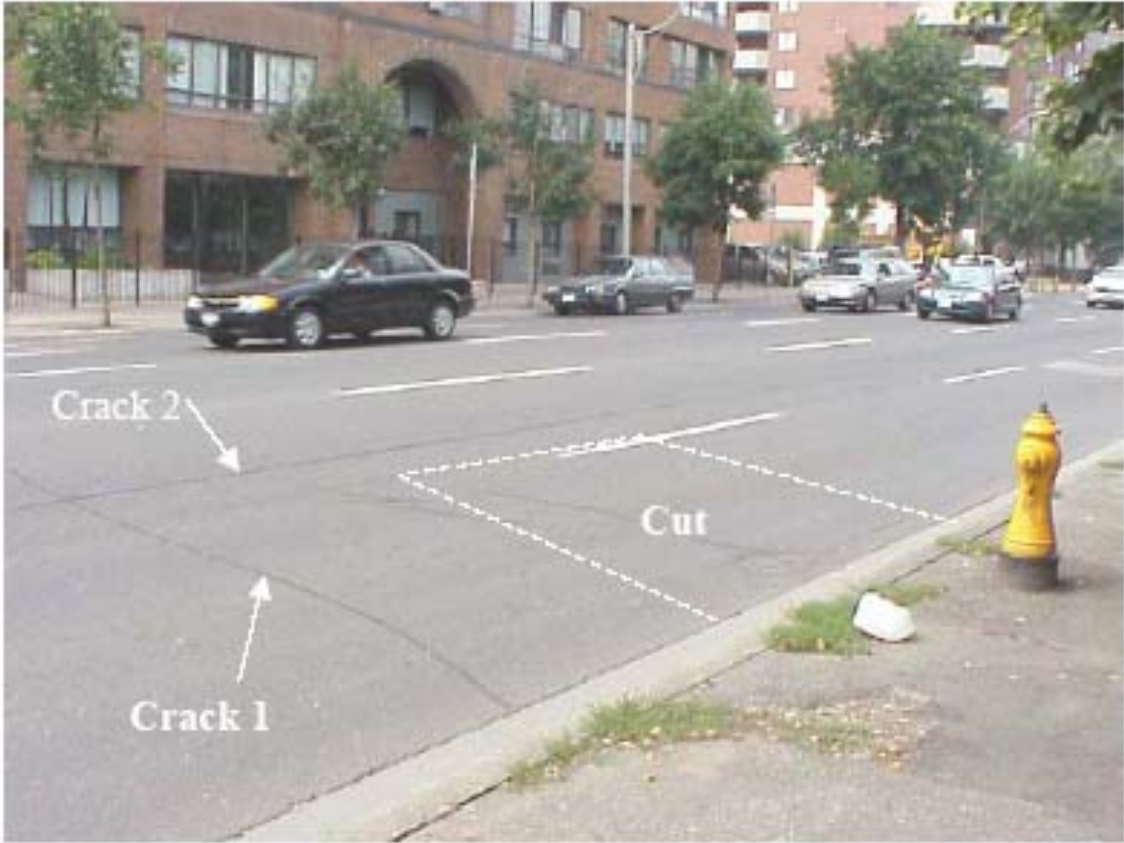
No changes observed in the shape or size of cracks identified during pre-construction damage survey.

Figure 9.5. Cracks observed before cutting the road

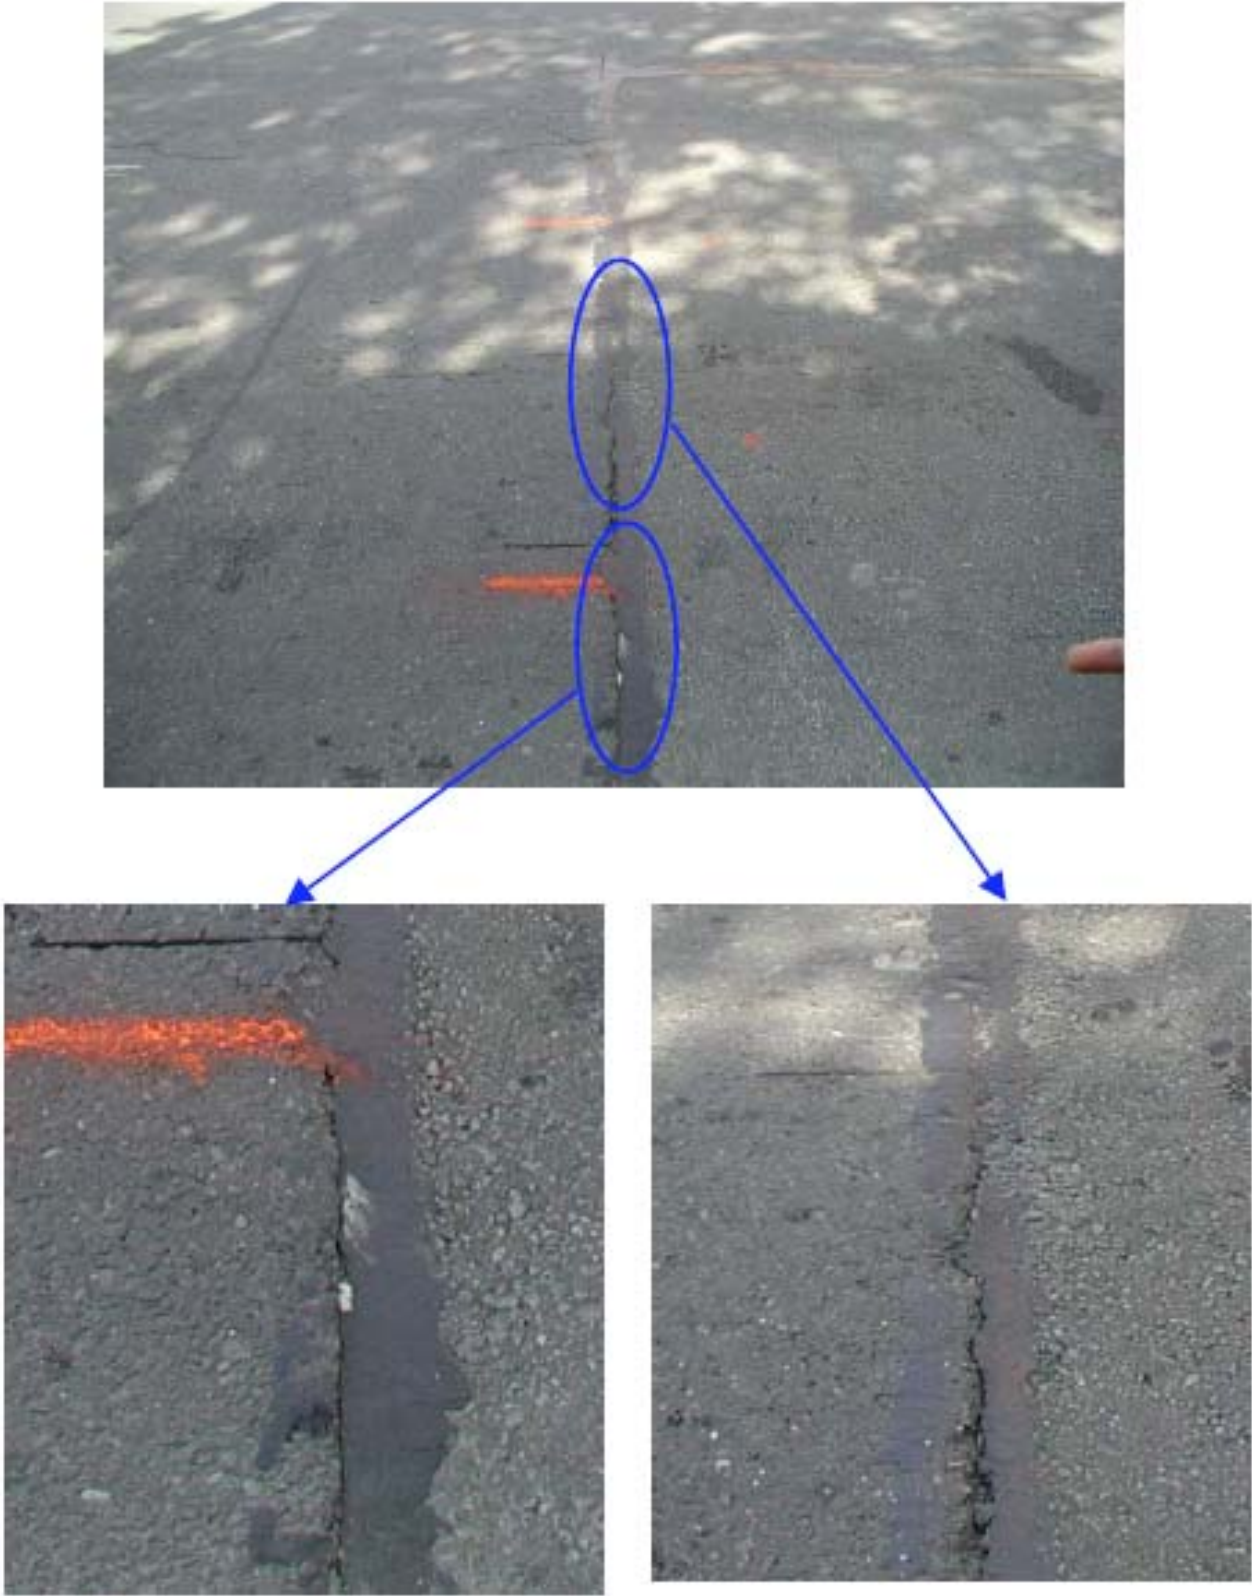
<b>Form 1: Damage Survey Form</b>			
<b>City:</b> Toronto, ON		<b>Site:</b> Jarvis Street.	
		Inspection Dates: Oct 2001, May 2002, April 2003	
Geometry/Structure (See Sections 2 and 5)	<b>ROAD</b>	<b>Utility Cuts</b>	
		<b>Trench</b>	<b>Keyhole</b>
	Number of lanes: 4	Width: 2.532 m	Diameter: (0.46 m) 18 in.
	Lane width: 3.35m	Length: 3.732 m	
Year of construction: NA	Date restored: Temporary: Oct 2001 Permanent: May 2002	Date restored: Oct 2001	
<i>Note: See Damage Survey Map (Figure 9.1) for details including location and orientation of observed damage patterns</i>			
<b>Ref. On Map</b> (Figure 9.1)	<b>Description</b>		<b>Details</b>
1&2	Theses two long cracks were observed during the distress survey performed before construction. They were sealed and no changes were observed during the May 20002 visit or afterward.		See Figure 9.5
3	The north and south road/cut joints separated at the indicated locations. Openings as wide as 2 mm (0.0787 in.) were observed during the May 2002 visit. The location of joint separation coincided with visible settlement in the trench (See details in Section 9.2).  The material used to seal the joint was lost under the action of traffic as a result of shear flow or pullout of the sealant.		See Figures 9.6 and 9.7

Figure 9.6. Major joint separations along the south edge of the trench

- ❑ The use of the T-section configuration at the AC layer level in Toronto is sought to reduce surface water infiltration into the restored cut. However, joint treatment is still needed to a safeguard against moisture effect; mainly weakening the resistance of soil based backfill layers to permanent deformations. Unshrinkable fill will drain surface water properly. However, the performance of the sand cover surrounded by a clayey subgrade material may be influenced by infiltration of surface water. Although there are other sources of moisture (pipe leakage or ground water), there are indications that the sand cover and surrounding clay in the Toronto restored cut were exposed to higher than normal levels of moisture (compared with the keyhole).

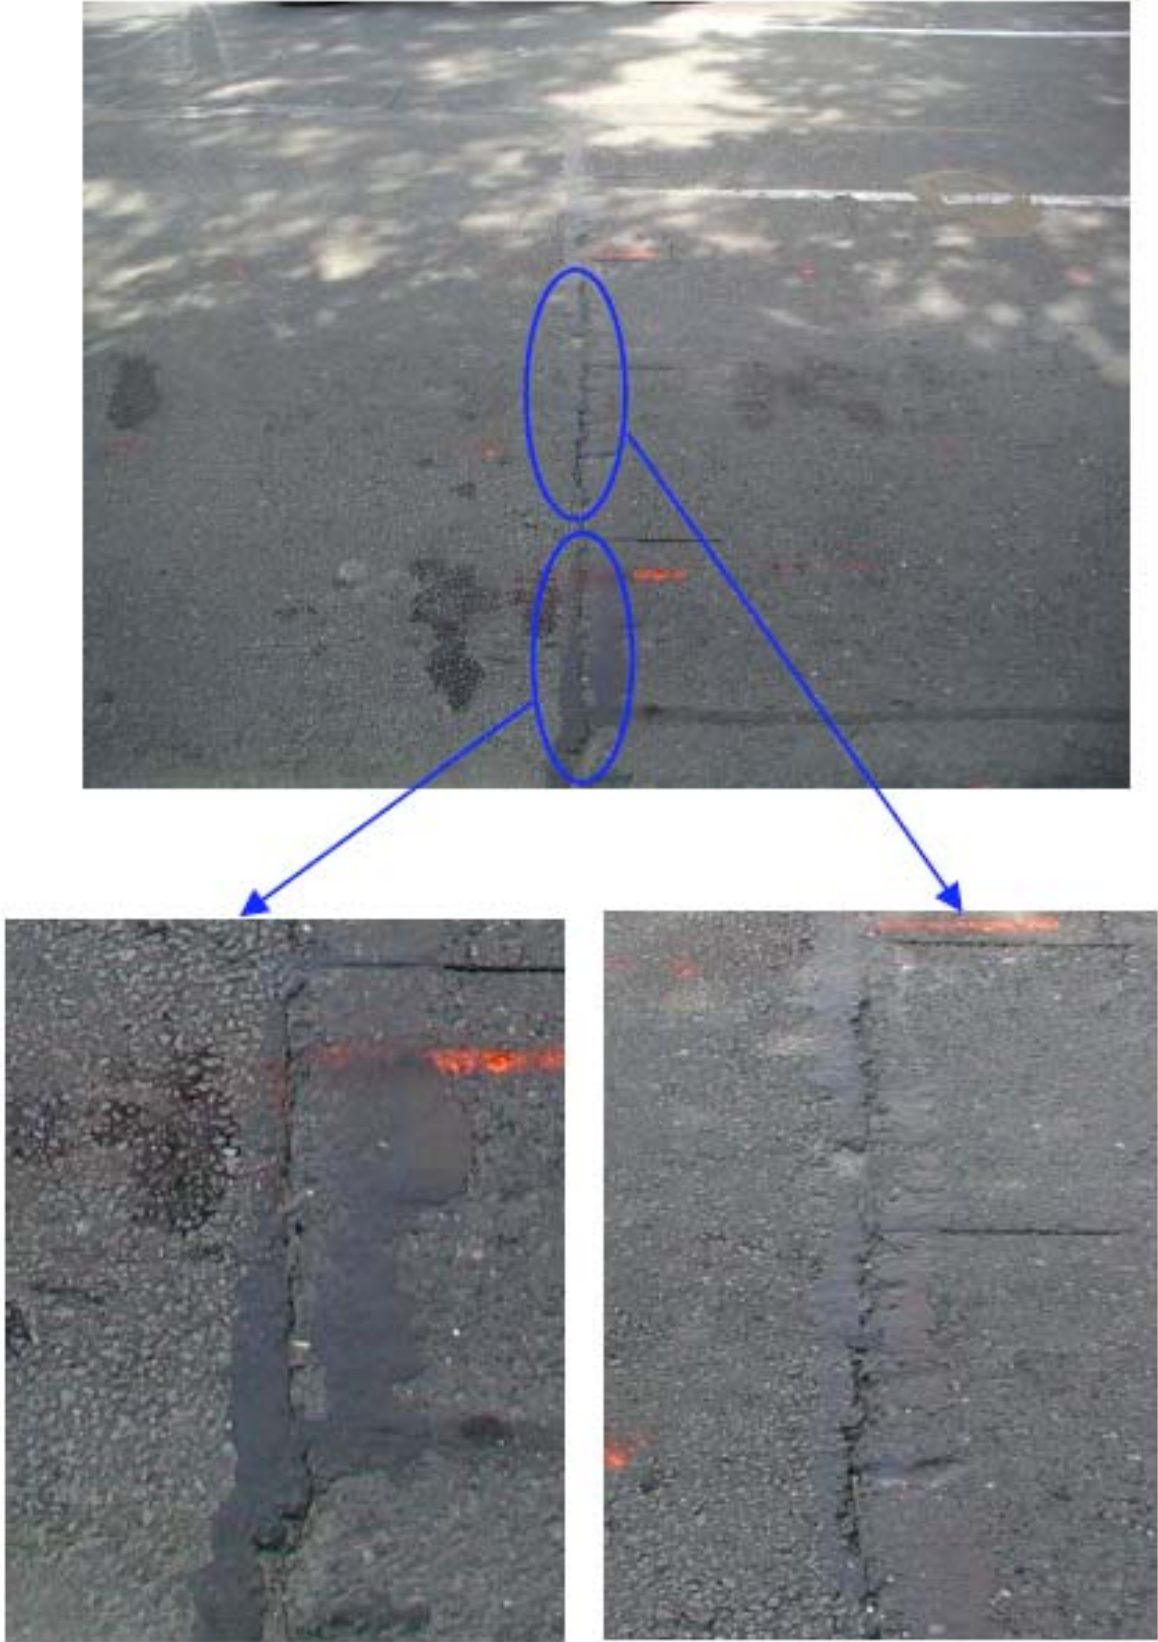
Figure 9.7. Major joint separation along the north edge of the trench

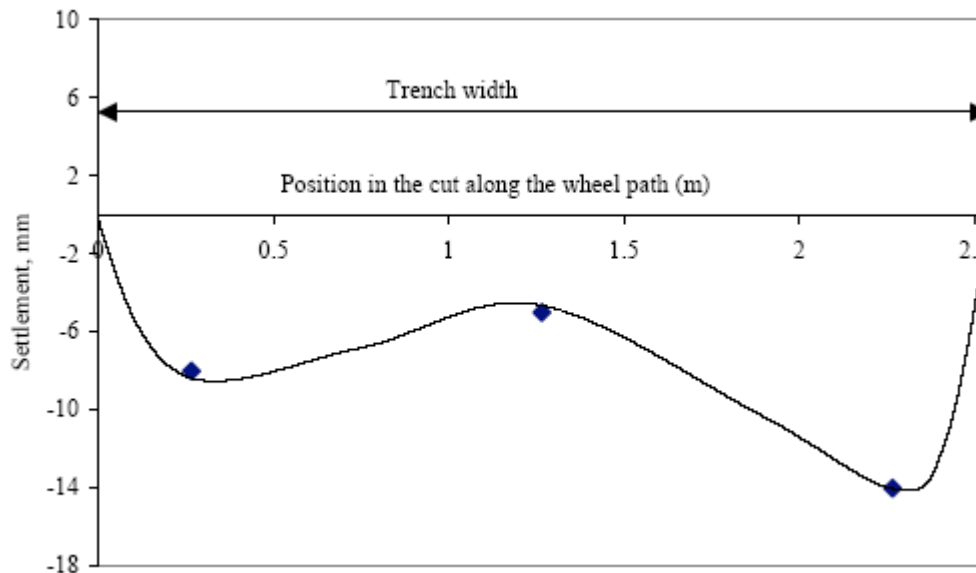
As mentioned above, surface elevations measured immediately after temporary restoration were used as a reference to determine the performance of the trench in terms of settlement. Settlement along the inner and outer wheel paths of Lane 4 reflected a similar trend as shown in Figure 9.8 and Figure 9.9. The edges of the trench experienced more settlement than the middle of the trench. Furthermore, settlement in the cut edge at which traffic exits the trench (north side) was approximately twice that at entry (14.4 mm, 0.571 in. compared with 7.5 mm, 0.295 in.)

Figure 9.8 Settlement in the trench along IWP – Temporary restoration (1 ft = 0.3048 m, 1 in. = 25.4 mm)

- ❑ The sand bed/cover was responsible for 75% of the settlement recorded during the temporary restoration stage in Toronto. It is recommended that the sand layer be treated as a structural layer with guidelines issued for controlling the quality of construction.

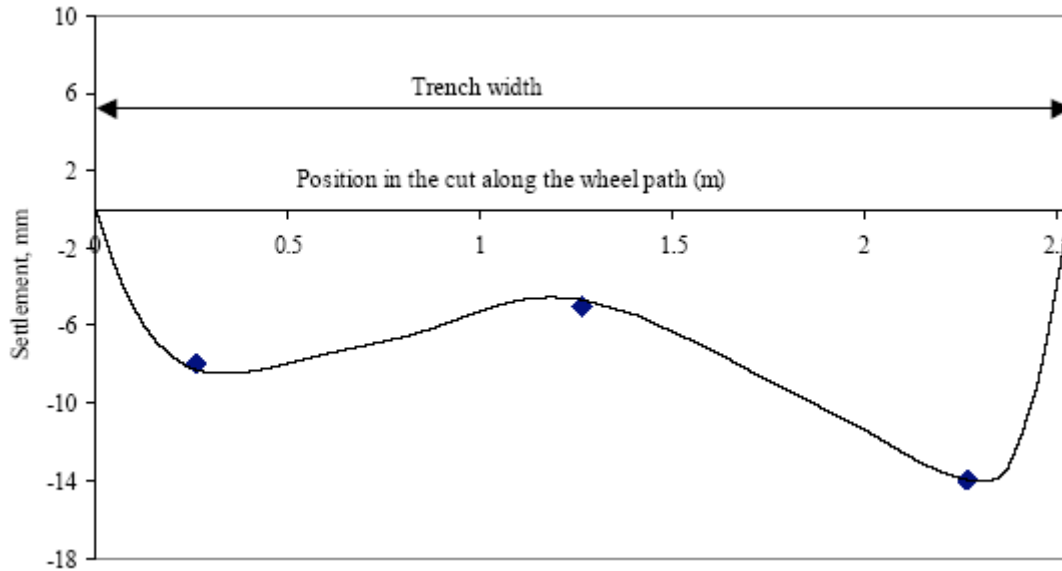
Figure 9.9 Settlement in the trench along OWP – Temporary restoration (1 ft = 0.3048 m, 1 in. = 25.4 mm)

Settlements in the cut, eight months after temporary restoration, established based on surface profile surveys agreed well with those measured by the extensometer. The extensometer, positioned in the sand cover directly below the outer wheel path measured 6mm settlement. Profile survey data showed 8mm settlement at the same location. Analysis of data from these two sources identified the sand layer as the source of the majority of settlement experienced by the cut at the location of measurements (75%). This result suggests that only 2mm deformation may be attributed to flowable fill and asphalt concrete layers.
