# ROAD UTILITY CUTS

## Field Investigation

*Toronto Site*

Report No.: B-5506.25

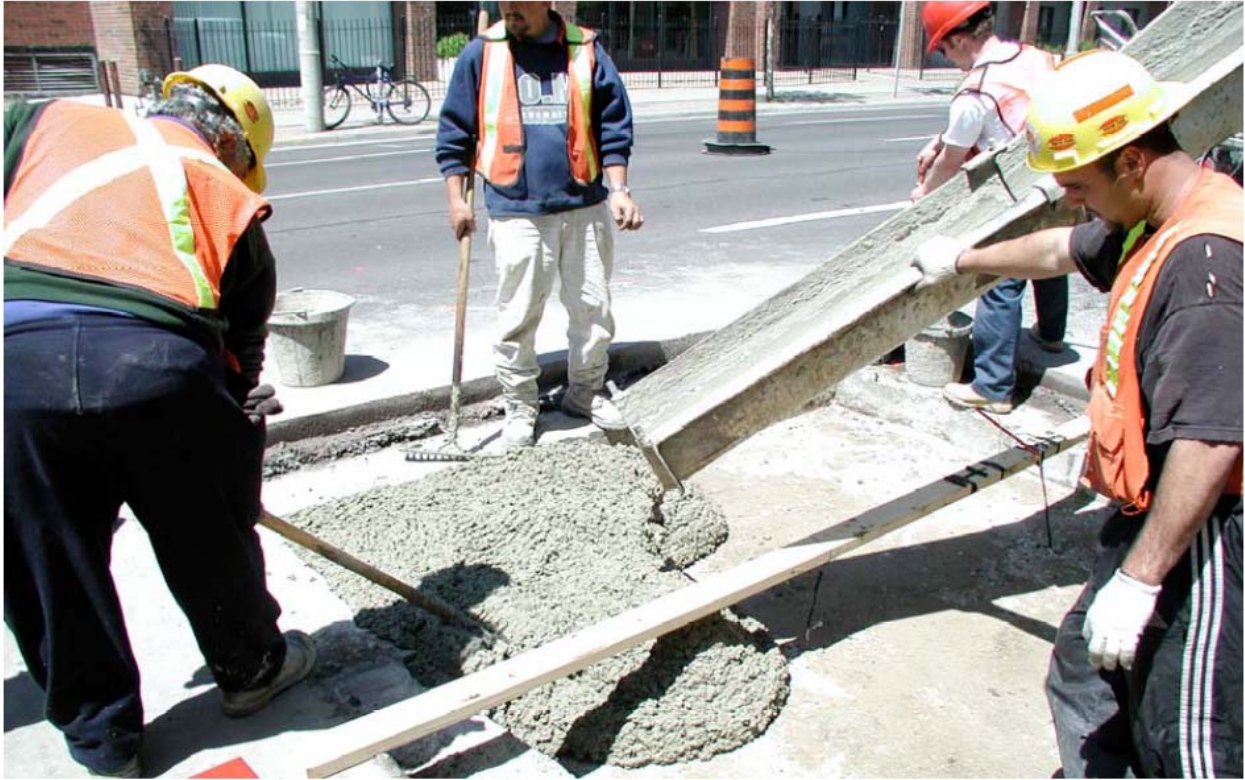
Figure 5.7. Casting of PCC base

Although permanent restoration was supposed to add an AC layer thickness of 100mm and 200mm of PCC, as-built plans indicate that 150 AC and 161 PCC were actually constructed. The thickness of the PCC slab was less than what exists in the road (PCC average thickness in the road was 200mm).

- ❑ The PCC curing period allowed was insufficient. Curing not only establishes the solid base needed for effectively placing the AC surface but is also required to sustain critical traffic loading without exposing the vulnerable AC surface to excessive deformations if the weak PCC slab is damaged. A well-cured PCC slab is also needed to limit the magnitude of stresses transferred to underlying backfill layers. The PCC was allowed less than 24 hours for curing, which is less than that needed to achieve adequate flexural strength. Although no adverse effect has been noticed as a result of this action, there is no guarantee that the restored location will continue to perform well in the future. Premature loading of the PCC causes cracking defying the purpose of casting a single continuous slab for effective load distribution capabilities.

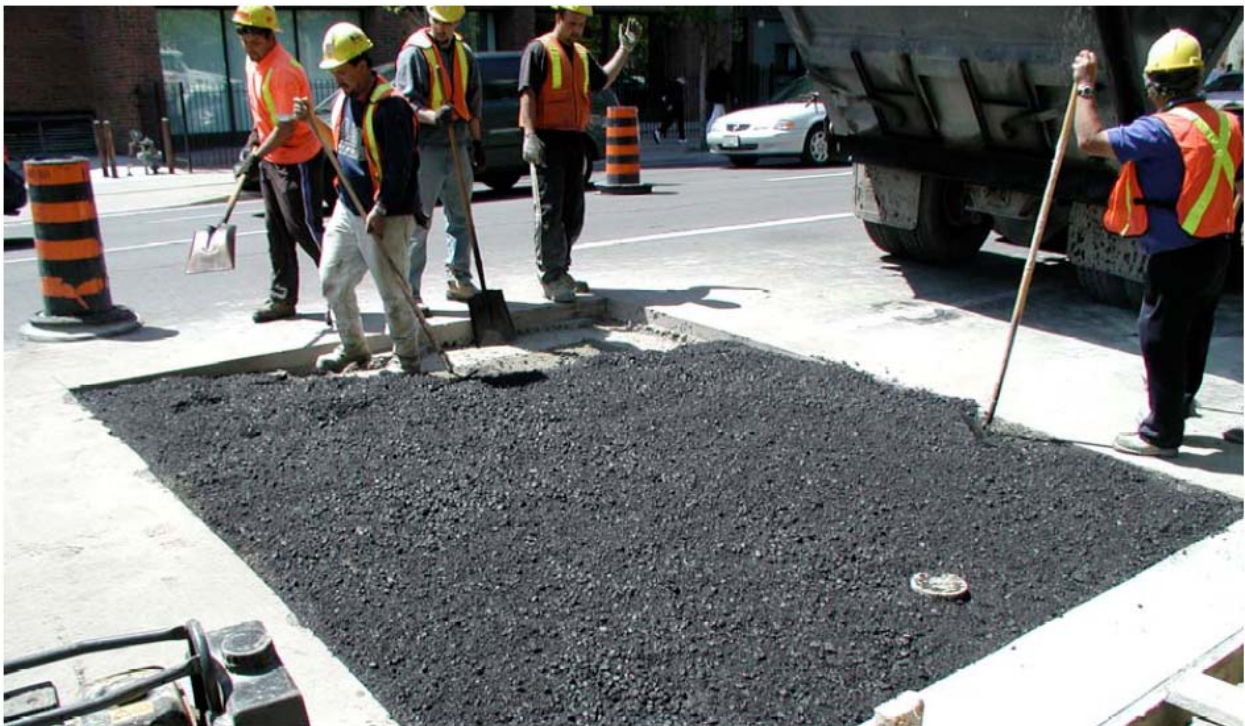
Figure 5.8. Placement of the HL8 layer on top of the PCC base

Toronto city specifications require a T-section configuration where the AC layer is extended approximately 350mm (1 ft) beyond the cut and into the existing road. The AC layer thickness was placed in two lifts. The lower lift was constructed with an HL8 mix. The upper lift was constructed with an HL1 mix (similar to the HL3 mix used in temporary restoration). Based on the use of a fast setting PCC mix, the AC layer was applied on top of the PCC the same day (difference of two hours between the application of the PCC and the HL8 AC).

Note	During construction related to permanent restoration, the steel roller compacting the lower AC layer (HL8) moved in and out of the cut causing damage at the edge of the cut. Placement of a wood beam eliminated the impact of the steel roller movements		See Figures 9.2 and 9.3.
Keyhole	The keyhole restored October 2001 showed no distress during the inspections performed during the May 2002 and April 2003 visits. The grout remained intact and the surface in level with the road.		See Figure 9.4

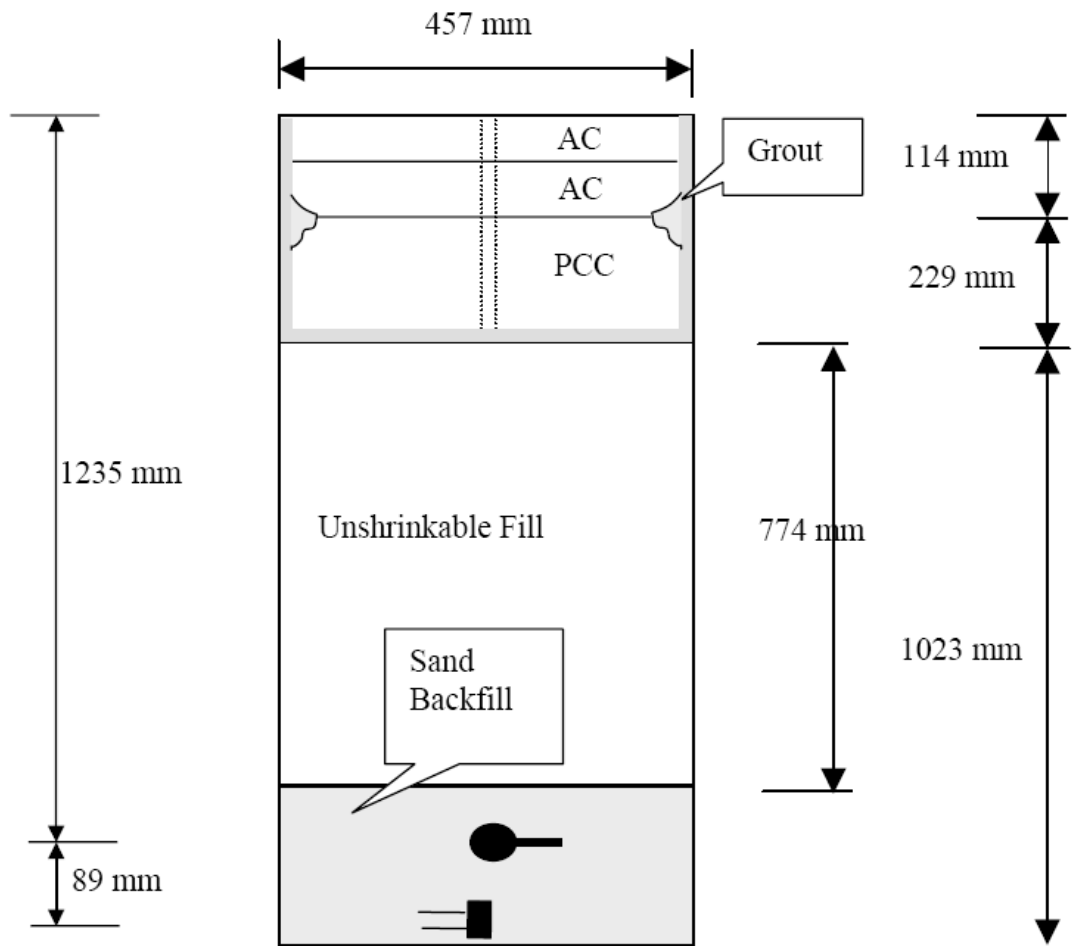
Figure 5.9. Keyhole restored with unshrinkable fill and original core removed during excavation – cross section DD marked in Figure 5.1 (1 in. = 25.4 mm)

Coring was performed using a machine mounted on a truck together with other accessories needed for removing material from the keyhole and for restoring the cut. The core, consisting of the road AC and PCC layers, was secured and reused afterward for surfacing the keyhole (See Figure 5.10). It was possible to differentiate between the two AC road layers (HL8 and HL3) present in the core on top of the PCC layer. Schematic reference to the loss of material at the AC/PCC interface observed in the core apparent in Figure 5.10 is shown in Figure 5.9.

The keyhole section established on October 2001 continued to perform well throughout the life of the experiment. The surface of the restored keyhole remained at level with the road profile. The grout surrounding the AC/PCC plug remained intact (no cracking or separation).
